# CRUSHER - ROTORS

TOTAL REFURBISHMENT OR MANUFACTURE  
OF NEW CRUSHER

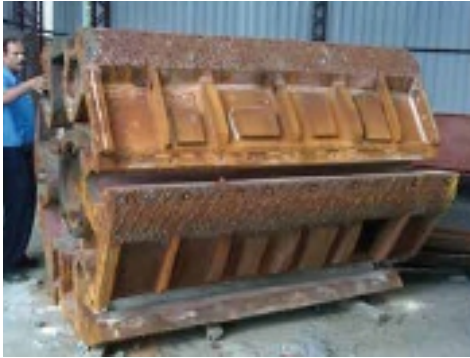
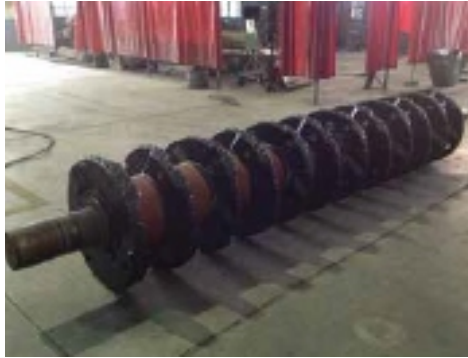
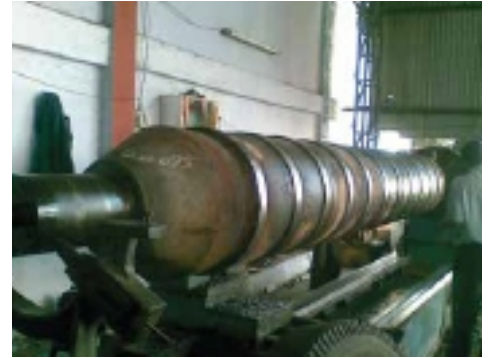
Rotor discs & Shaft wears out due to mild/heavy impact & abrasion. The enlarged pin diameter and thinning of discs makes it difficult to operate rotor smoothly. Many times, blow bar holder also breaks making it impossible to operate.

Refurbishment is carried out by replacement of all discs but retaining used shaft in case of hammer crusher. For Blow Bar Crusher Rotor, total health check-up of rotor is carried out for cracks etc.

- Removal of old discs
- Levelling of shaft surface
- NDT of shaft
- Cutting & machining of new discs
- Fitting & alignment of new discs over used shaft
- Joining of new discs by welding & Stress relieving
- Hard deposit over wear prone area of discs
- Line boring & finishing
- Inspection
