# GRINDING PATH

COMPLETE WEAR PROTECTION OF  
GRINDING PATH OF IMPACT CRUSHER

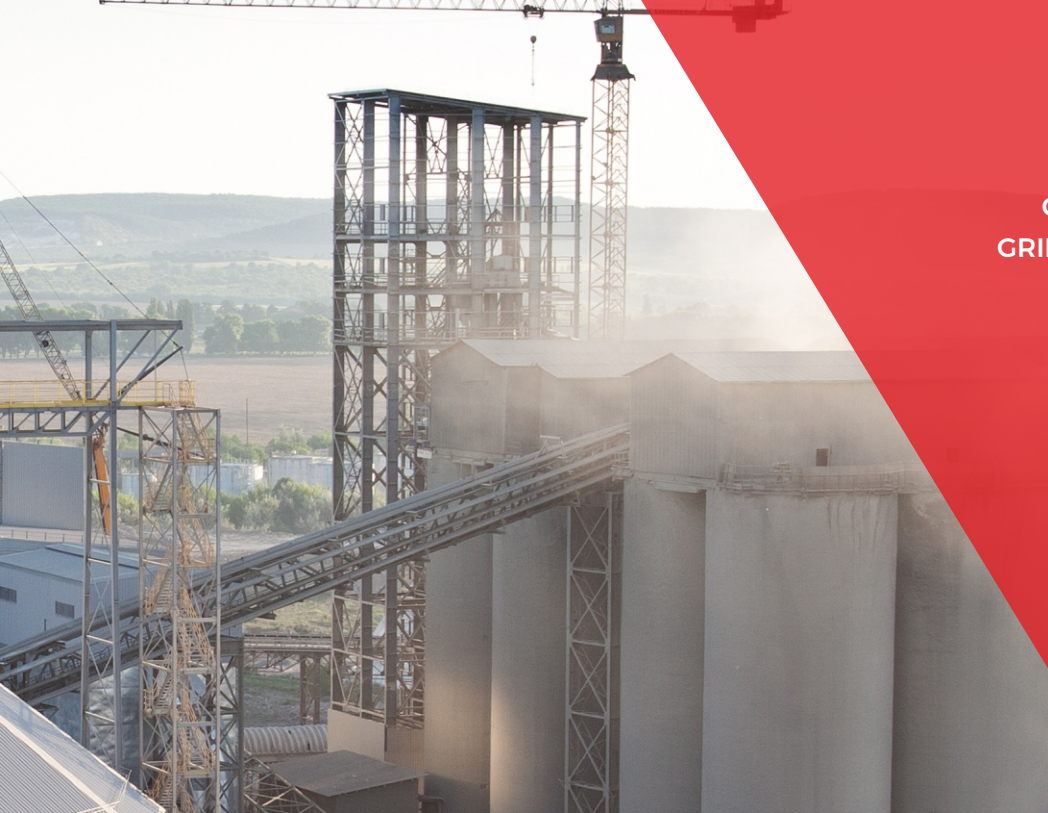
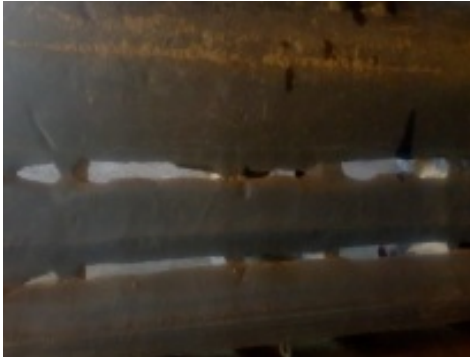
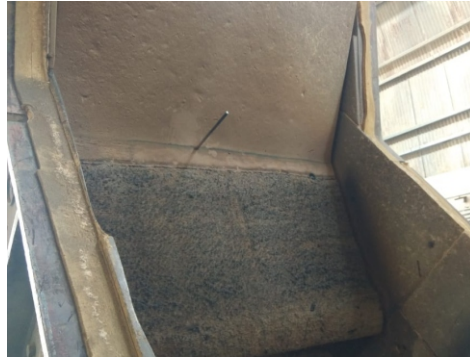
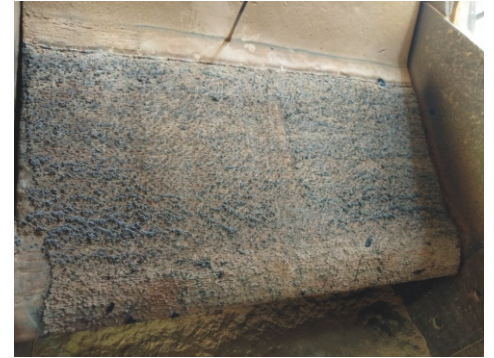
Hydraulic impact crusher is primarily used for crushing of limestone. Grinding path is a component inside the impact crusher which gets totally worn out due to heavy impact and abrasion. Impact crusher is critical for production of limestone (Raw material) for manufacturing cement, so any stoppage involves huge down time and production loss. Solution to this problem is replacement with new grinding path which is costly proposition or re-conditioning of the worn-out grinding path by welding.

ADFL method for re-conditioning of grinding path is completely re-enforcing the worn-out area with Mn steel plates. Complete cladding in the wear portion with our unique single alloy system LH Tuff Tech-58 ideal alloy for high impact combined with high abrasion.
